TECHNICAL INSPECTION REPORT

OPERATION CROSSROADS. U.S.S. SKIPJACK (SS184).
TEST BAKER, VOLUME 2[U].

Bureau of Ships Group technical inspection rept.,

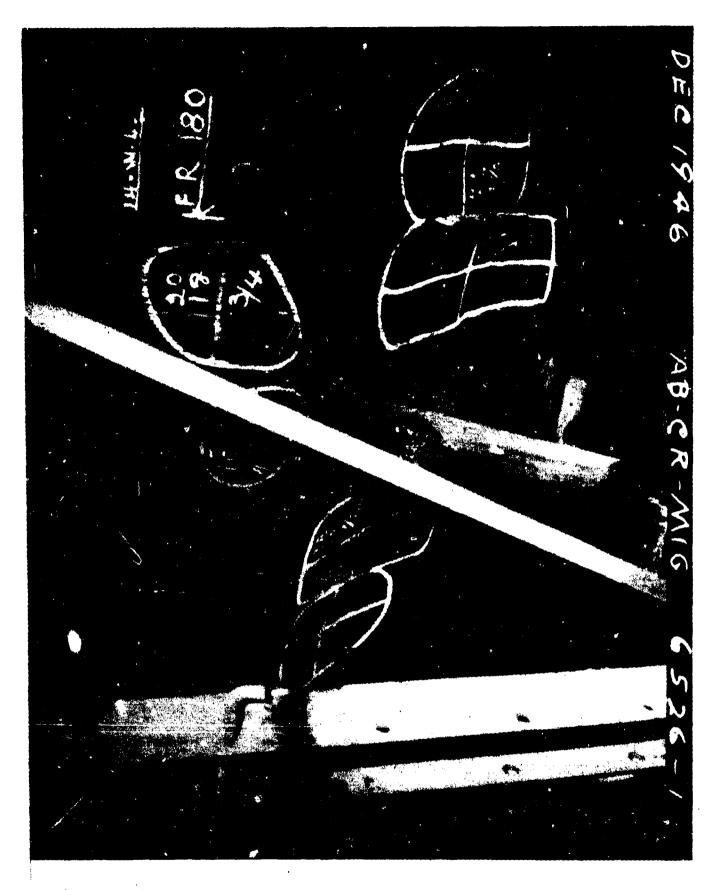
AB-CR-MIG-6526-1. Dimples in non-circular pressure hull - frames 179-184, starboard.

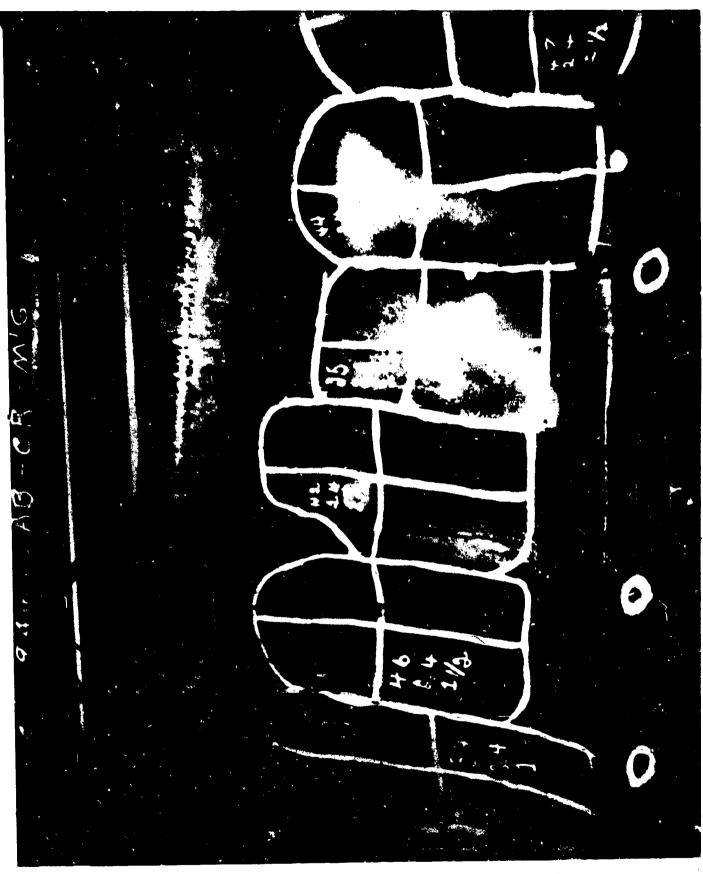
AB-CR-MIG-6525-6. Dimples in non-circular pressure hull - frames 176-181, starboard, lower part.

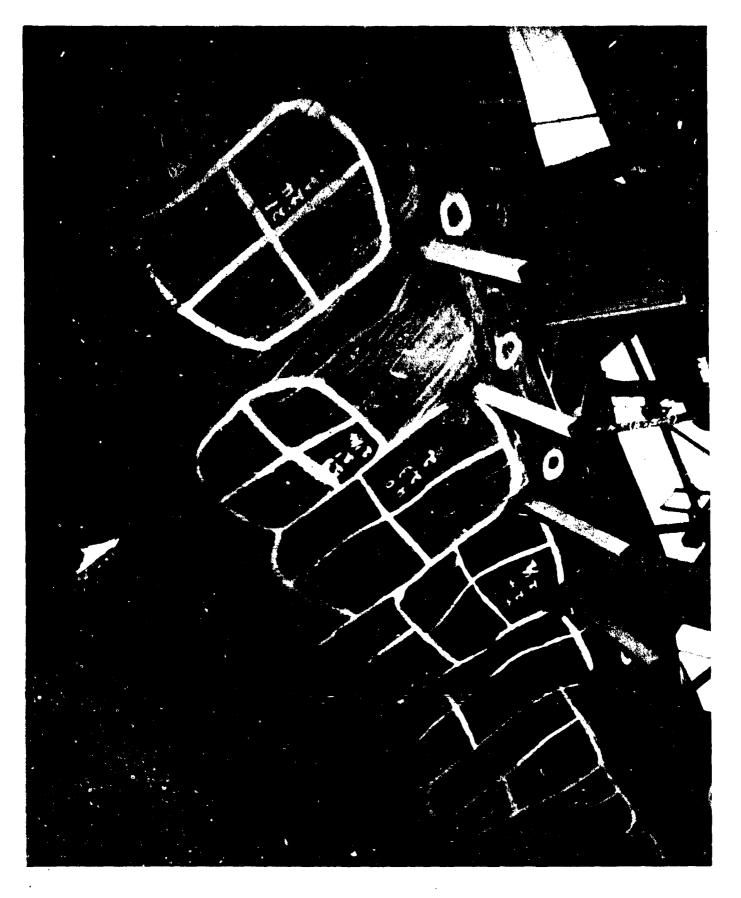
AB-CR-MIG-6525-5. Dimples in non-circular pressure hull - frames 172-178, starboard, lower part.

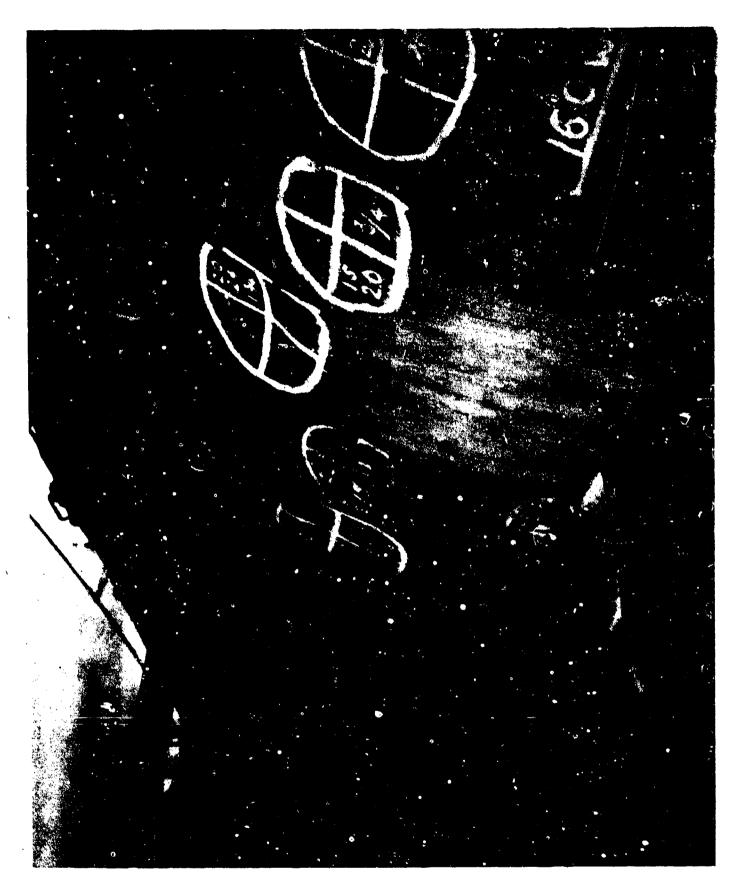
AB-CR-MIG-6526-3. Dimples in non-circular pressure hull - frames 174-178, starboard, at 18' water line.

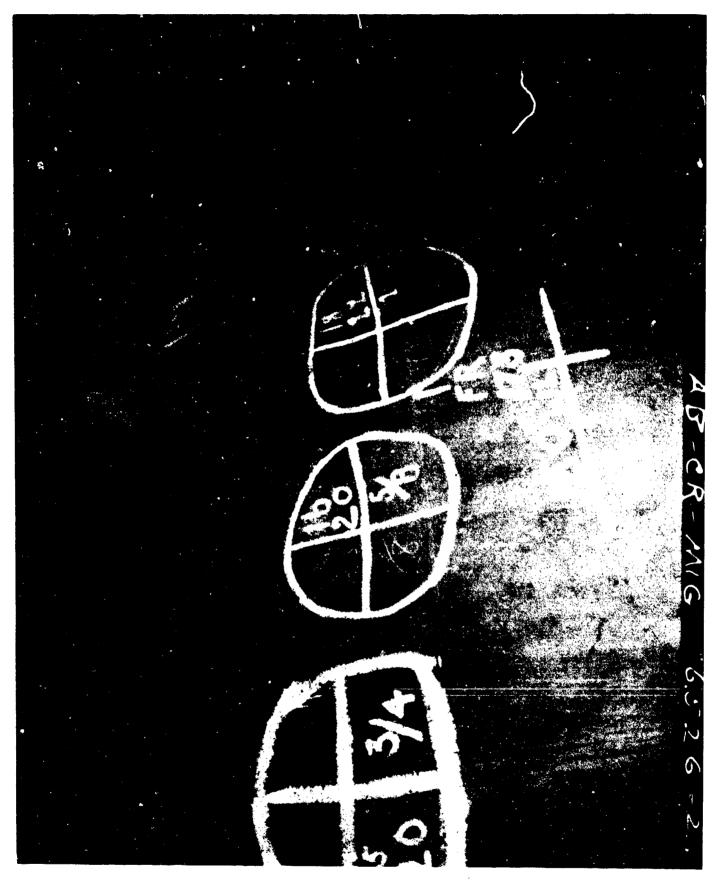
AB-CR-MIG-6526-2. Dimple in non-circular pressure hull-frames 171-175, starboard at 18' water line.

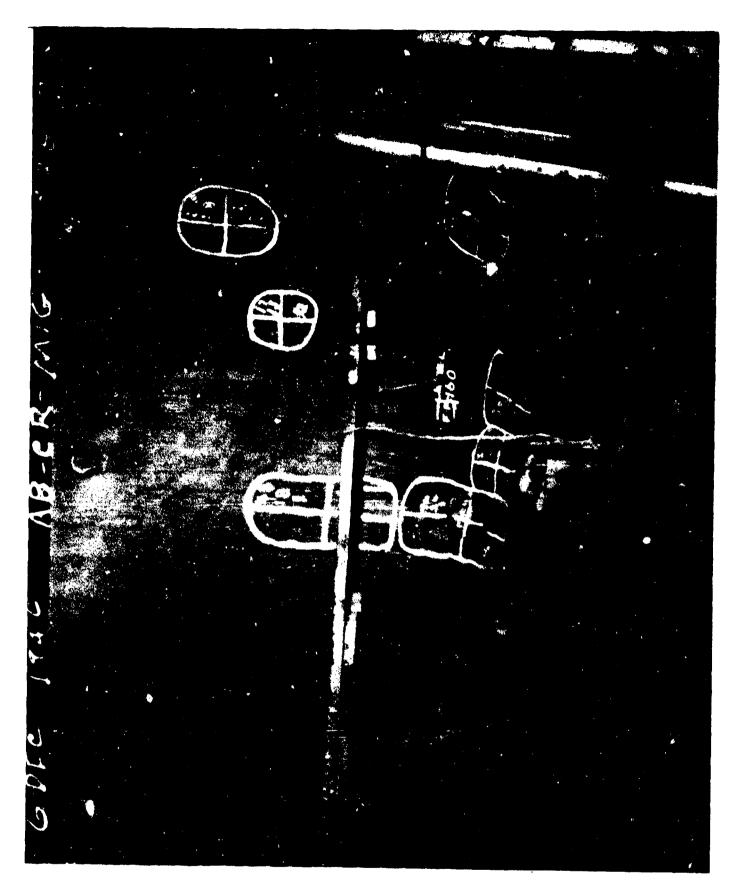
AB-CR-MIG-6525-7. Dimples in non-circular pressure hull - frames 157-164, starboard.

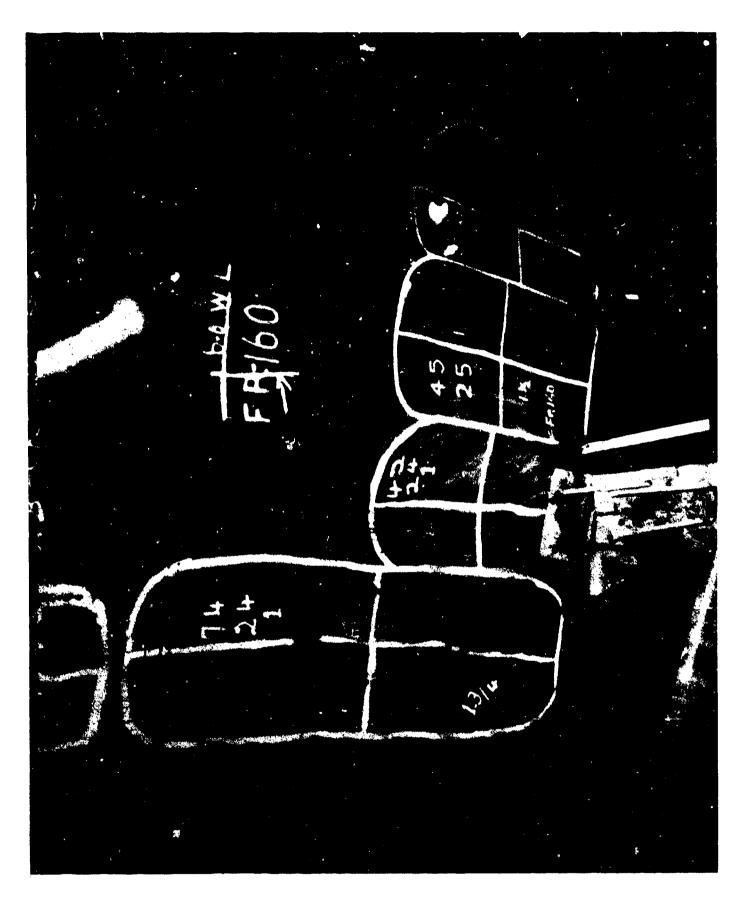
AB-CR-MIG-6525-8. Dimples in non-circular pressure hull - frames 157-162, star pard.

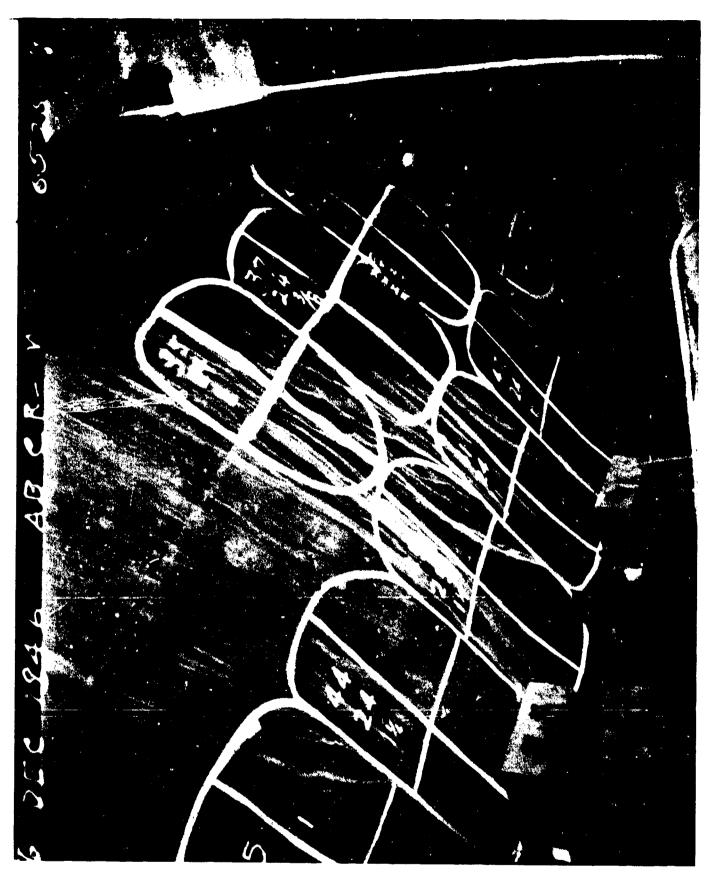
AB-CR-MIG-6525-9. Dimples in non-circular pressure hull - frames 153-159, starboard.

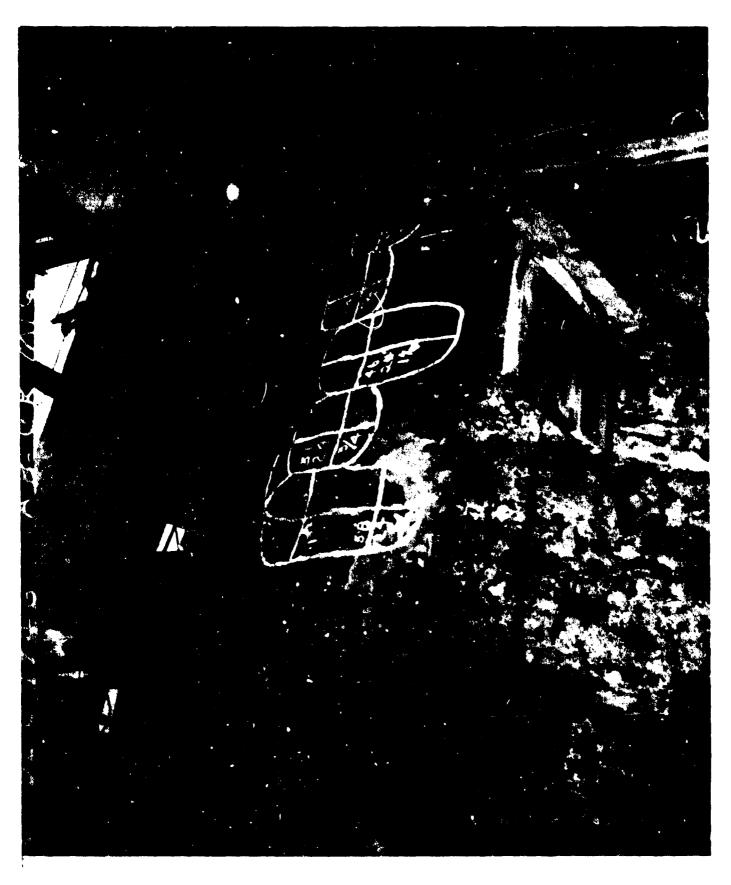
AB-CR-MIG-6525-10. Dimples in non-circular pressure hull-frames 27-33, starboard.

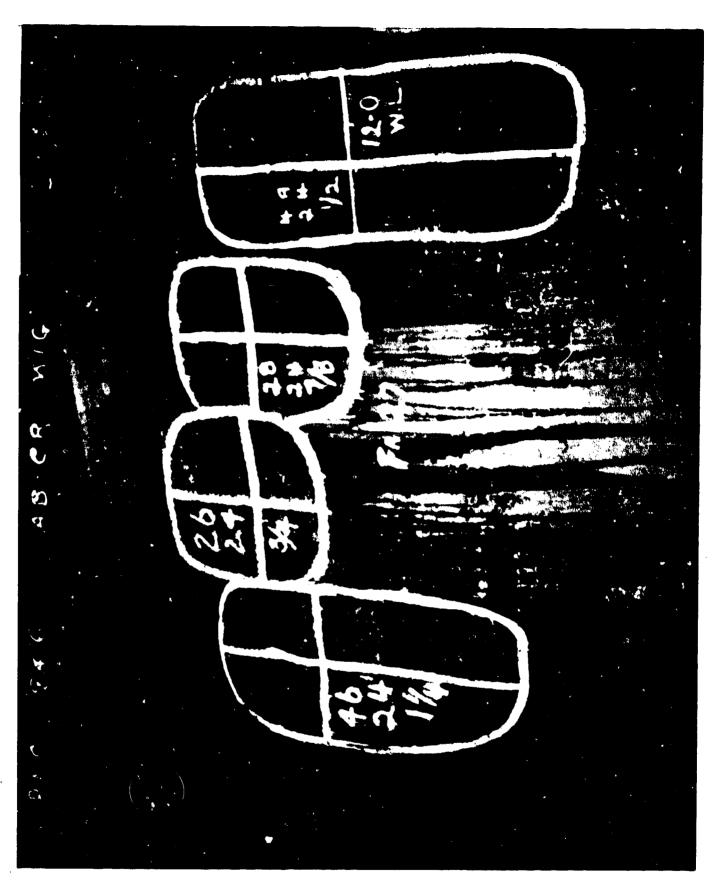
AB-CR-MIG-6525-2. Dimples in non-circular pressure hull - frames 25-29, starboard.

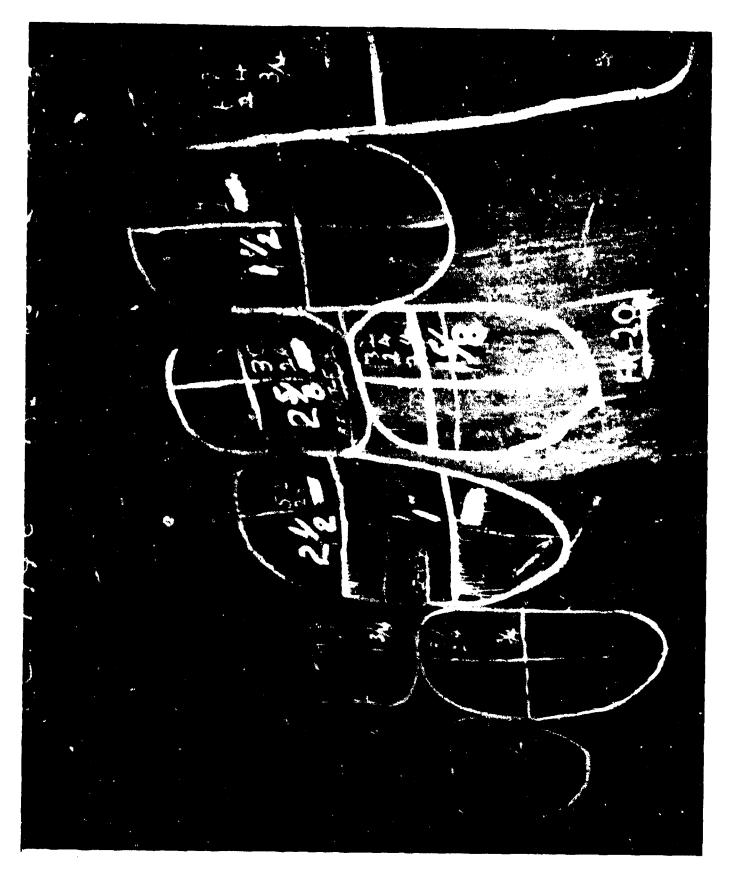
AB-CR-MIG-6528-11. Dimples in non-circular pressure hull - frames 19-24, starboard.

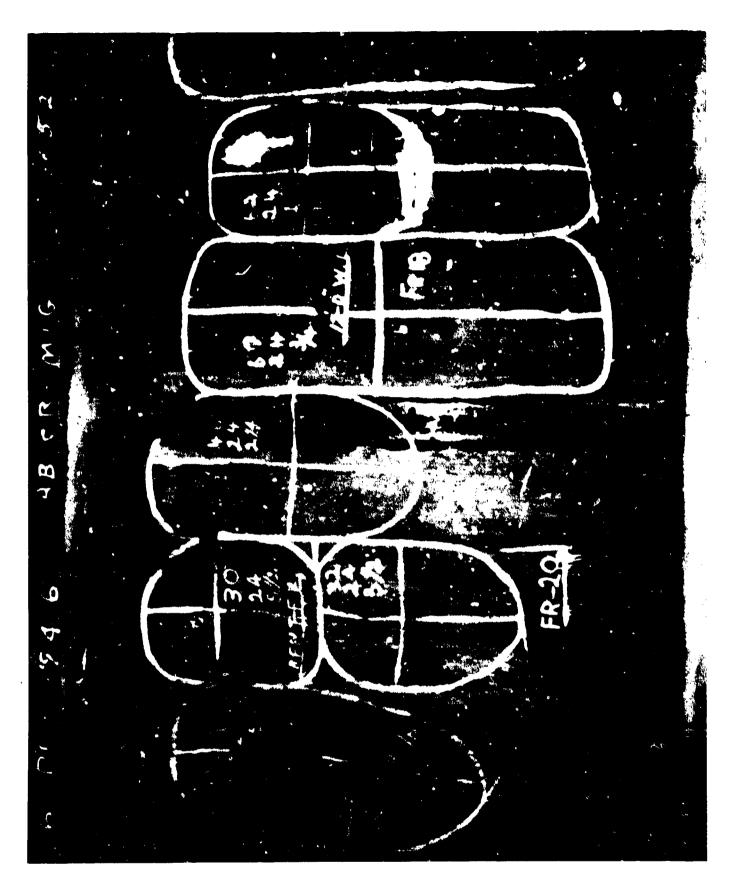
AB-CR-MIG-6525-1. Dimples in non-circular pressure hull - frames 17-22, starboard-

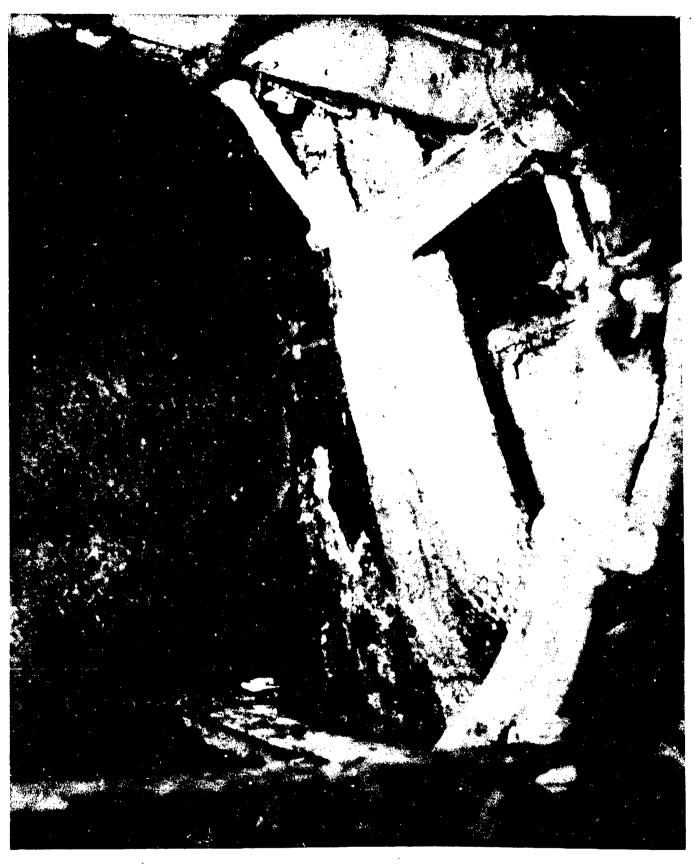
AB-CR-MIG-6516-6. View of plating fracture at frame 30, port, looking up from interior.

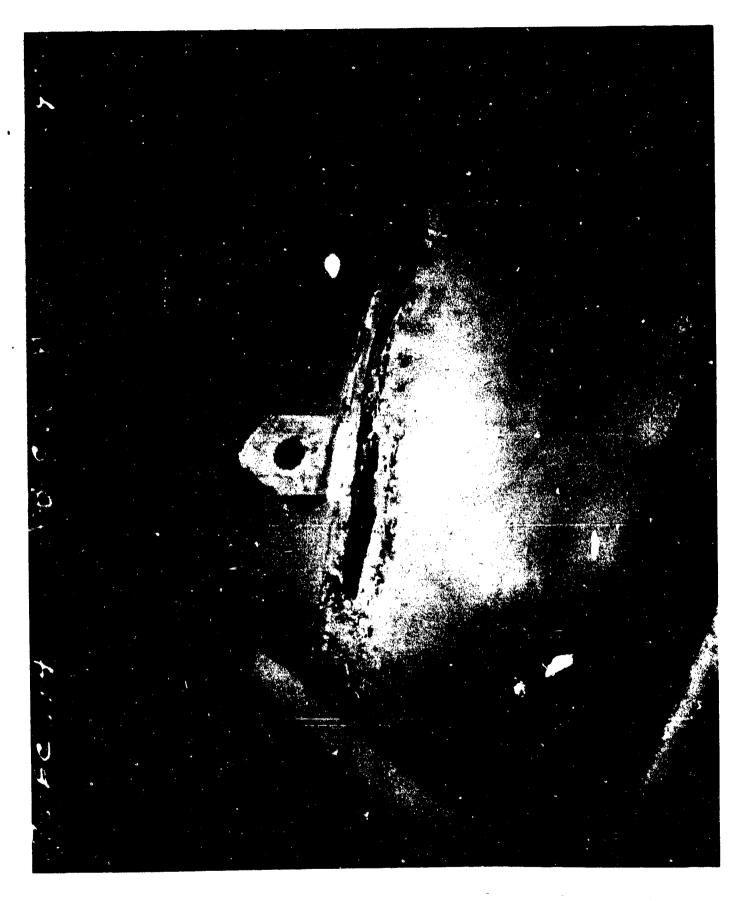
AB-CR-MIG-6529-2. Plating fracture at frame 30, port, after repair weld was removed.

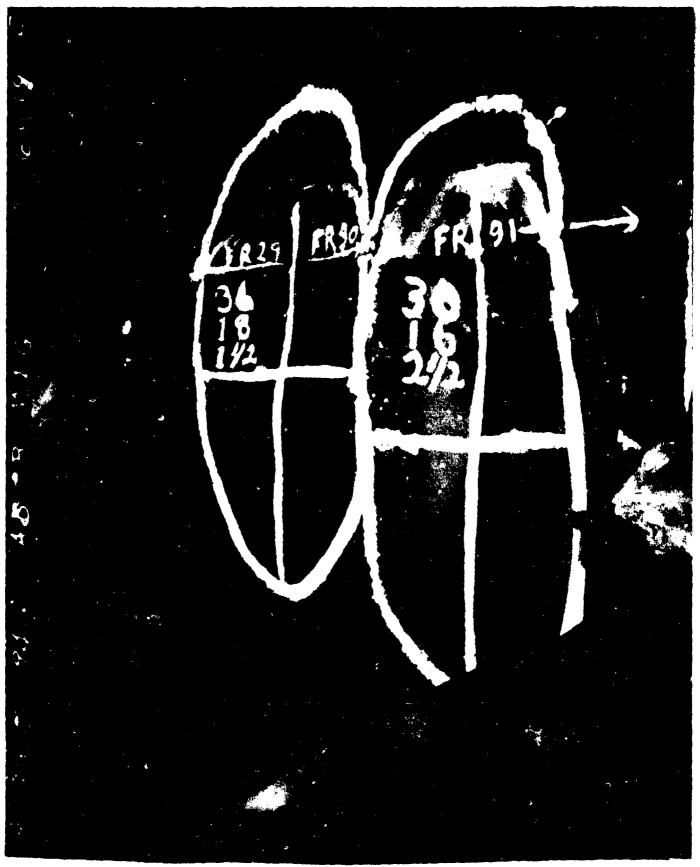
AB-CR-MIG-6518-5. Dimple in top of non-circular pressure hull - frames 29-31 port.

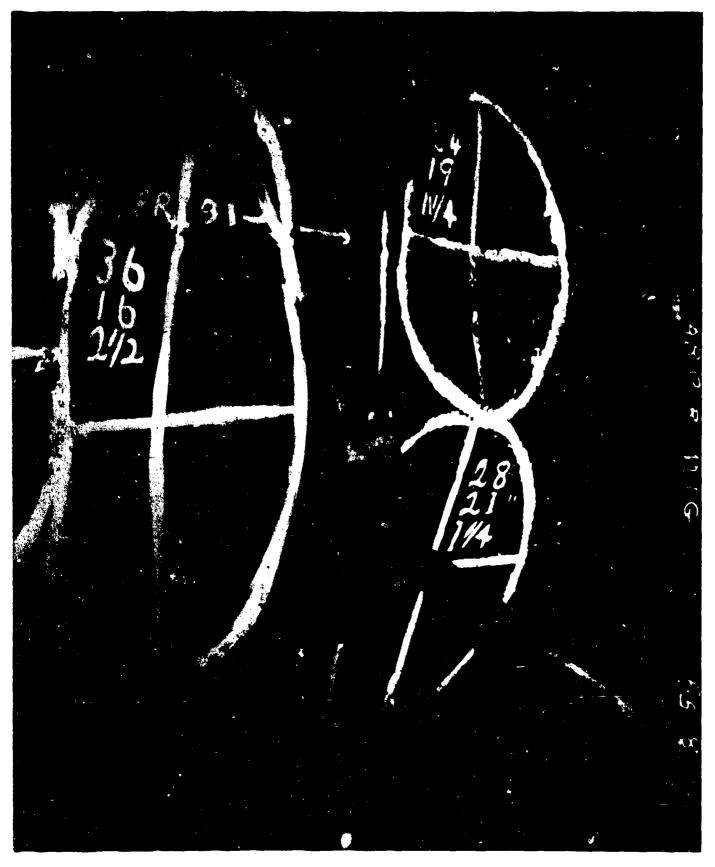
AB-CR-MIG-6518-6. Dimple in top of non-circular pressure hull - frames 30-32 port.

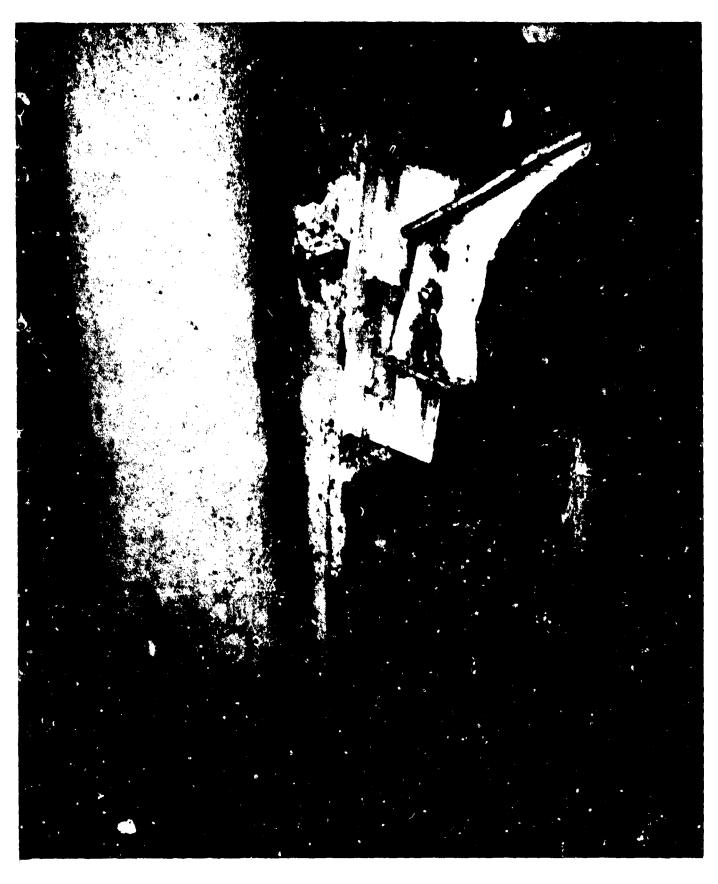
AB-CR-MIG-6528-4. Bulge in frame 31, port, 4'above tank top - Looking forward.

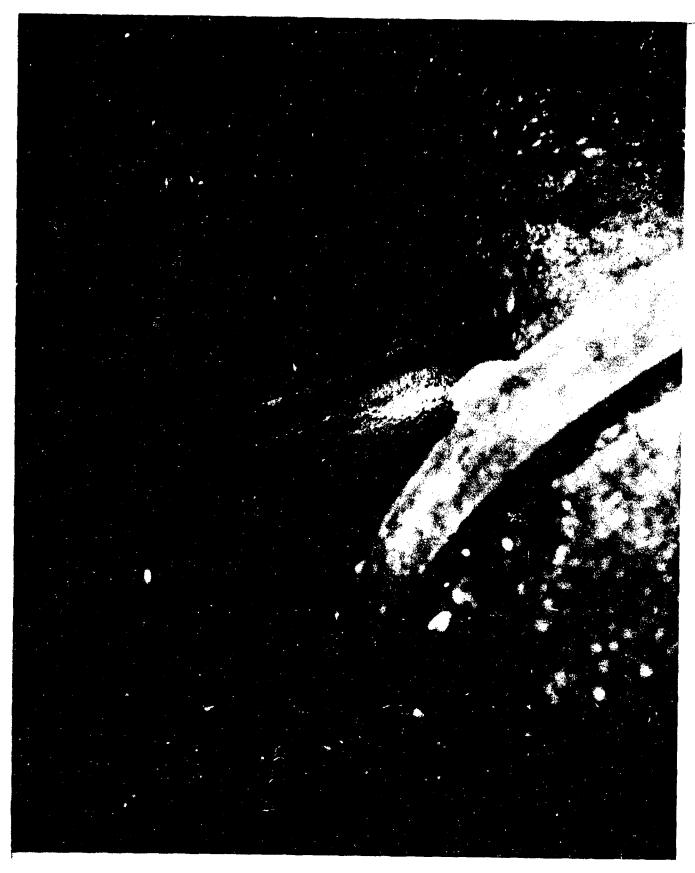
AB-CR-MIG-6528-6. Collapse of floors at frames 177 and 178, just to starboard of keel. Looking aft.

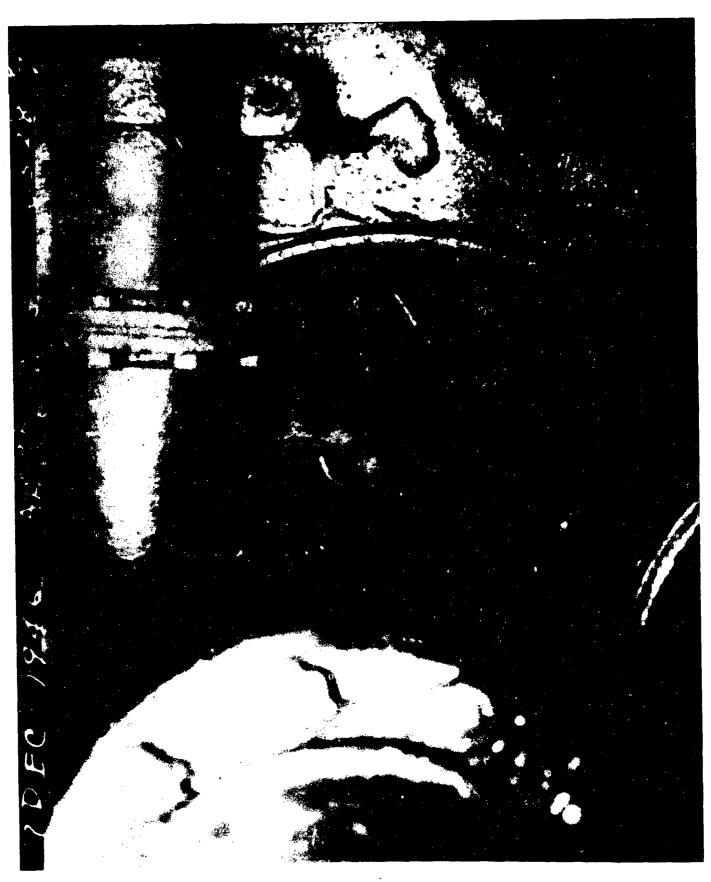
AB-CR-MIG-6528-7. Collapse of floors at frames 177 and 178, just to port of keel. Looking aft.

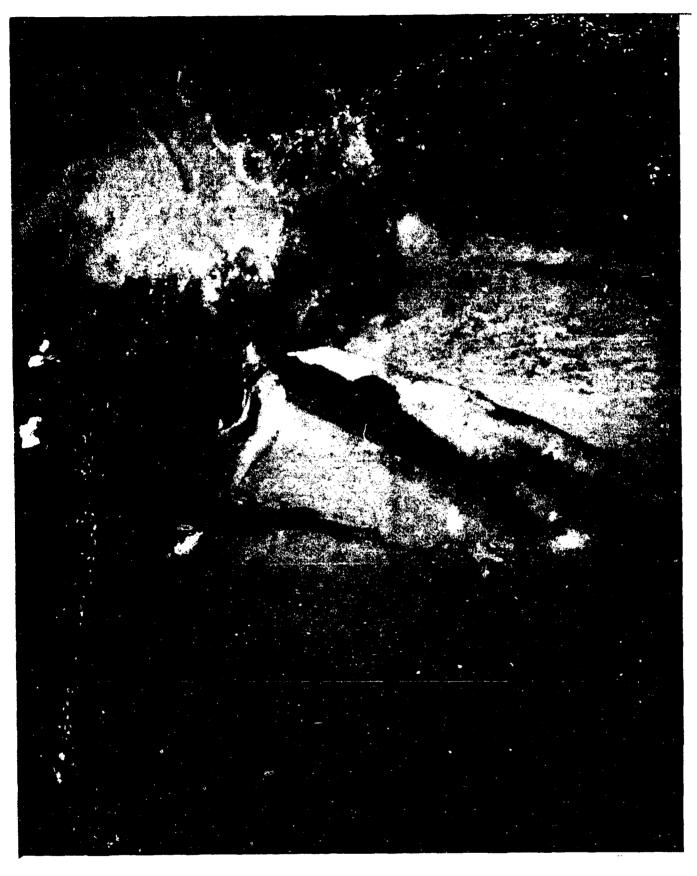
AB-CR-MIG-6520-8. Frame 24, starboard. Cracked weld at intersection of face plate in bulkhead with tank top.

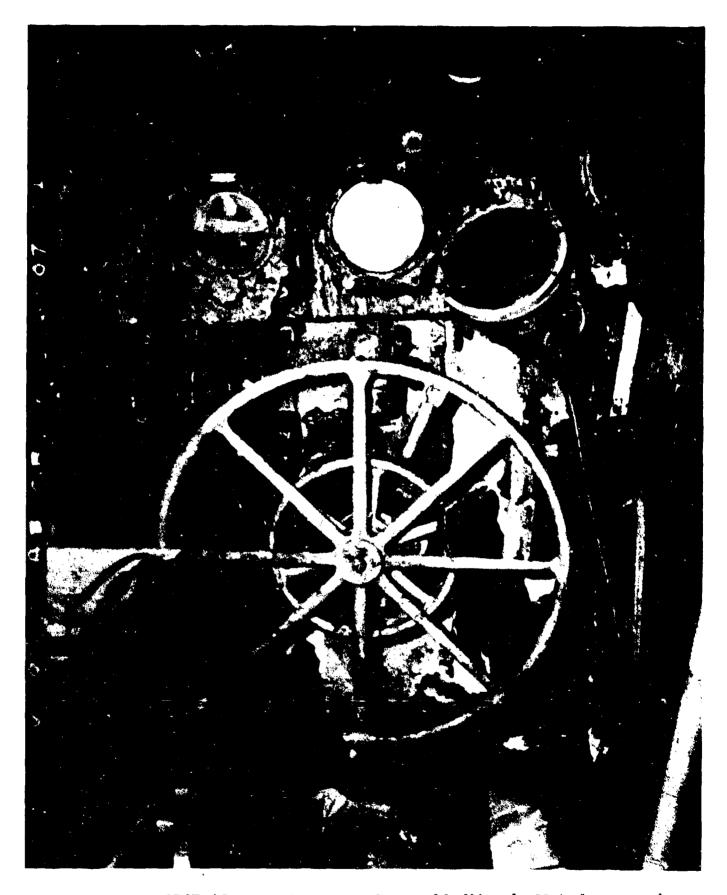
AB-CR-MIG-6507-12. Conning tower forward bulkhead. Note loose cork.

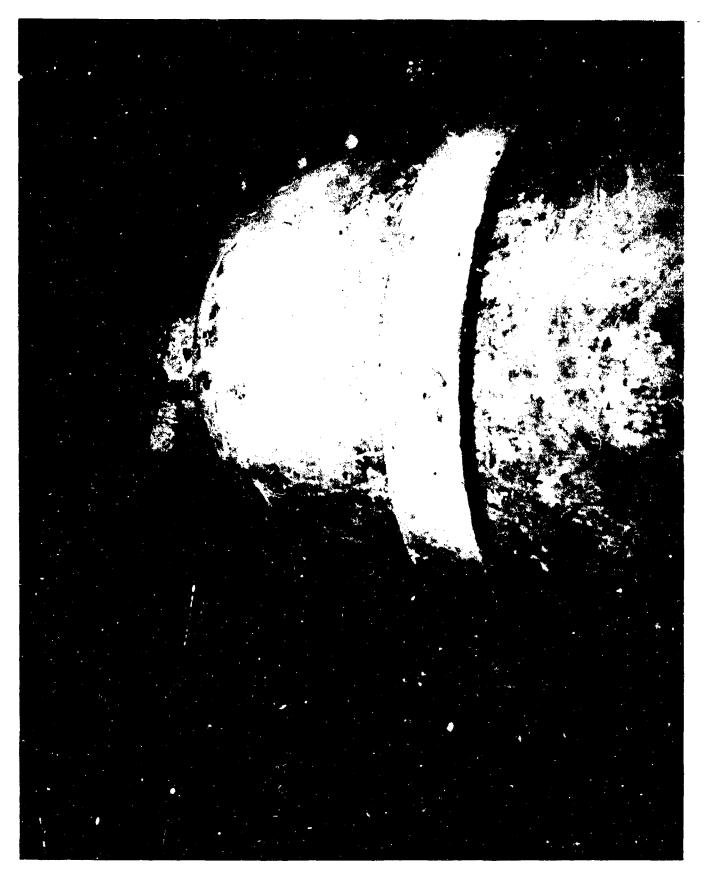
AB-CR-MIG-6519-7. Accumulator Air Flask in pump room.

AB-CR-MIG-6519-7. Accumulator air flask in pump room showing pipe adaptor broken off flask head.

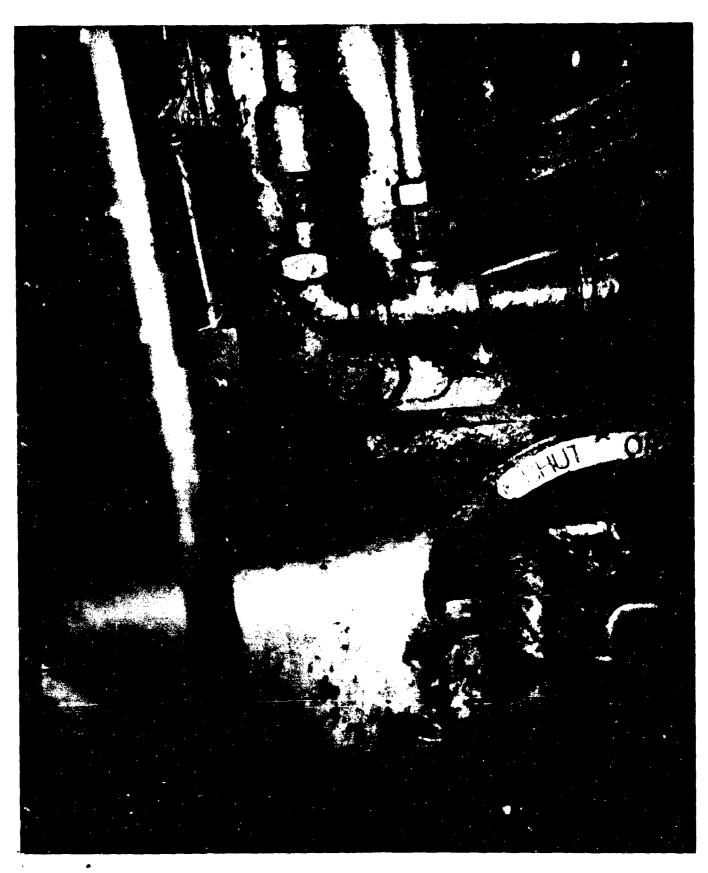
AB-CR-MIG-6515-9. Fracture of after inboard foot of No. 2 turbo blower.

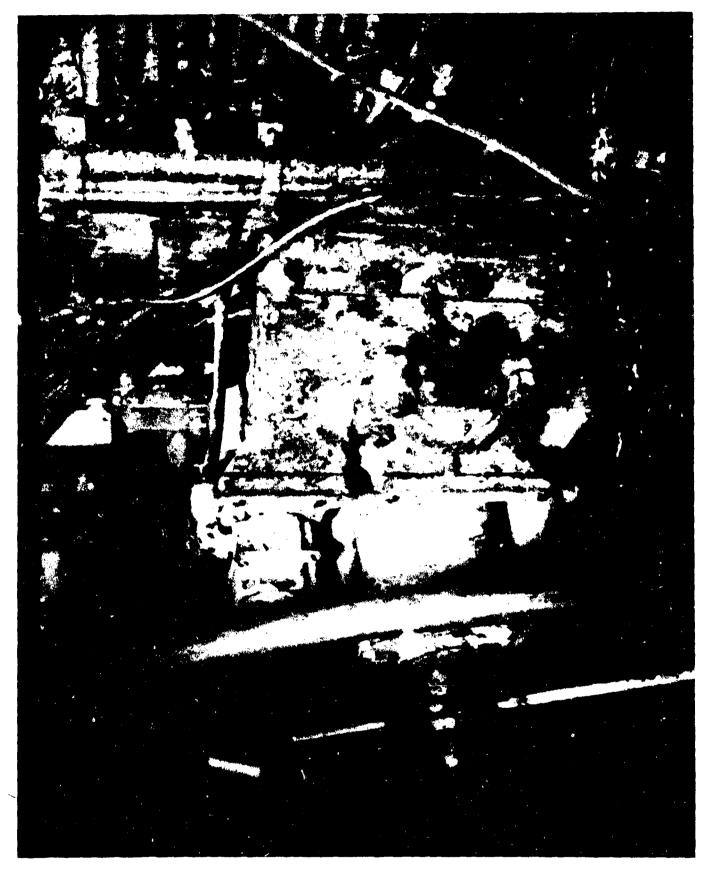
AB-CR-MIG-6511-8. Fracture of housing for stern place hand lifting gear box.

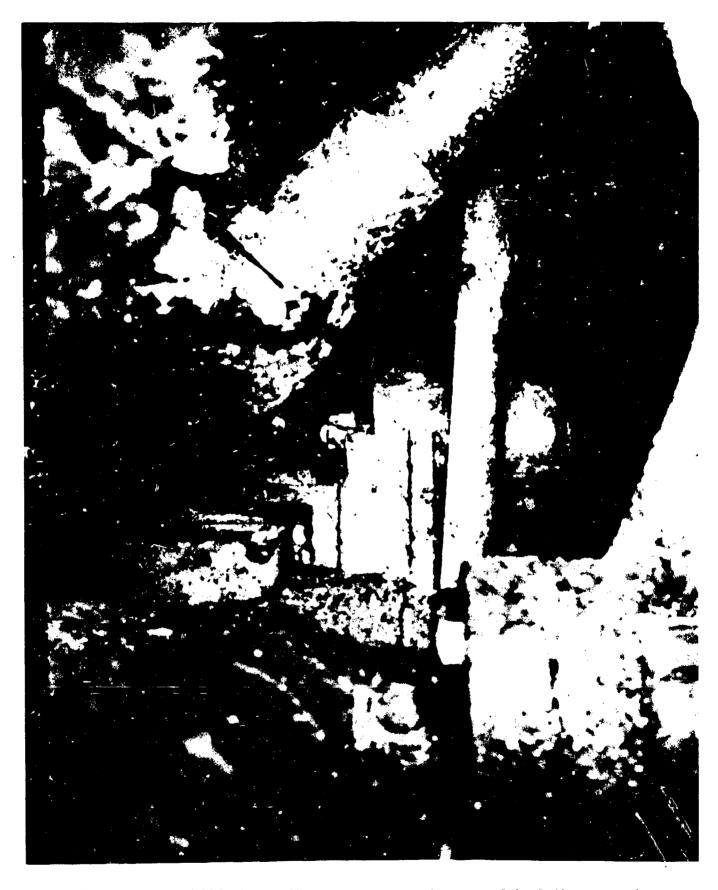
AB-CR-MIG-6516-7. Radio motor generator sound isolation mount.

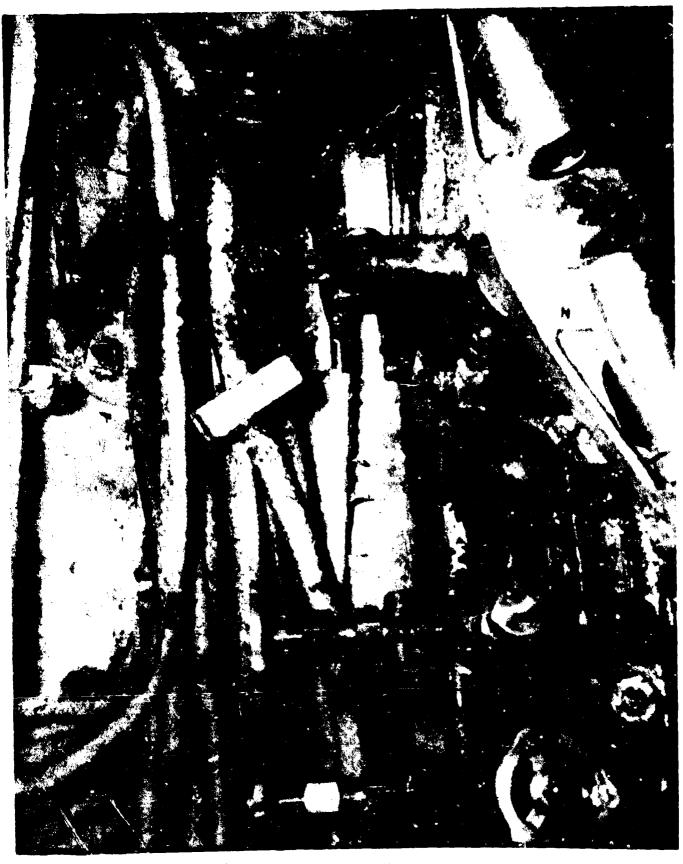
AB-CR-MIG-6507-10. Main ballast tank 2 H - flood valve operating gear. Note wooden plug where grease fitting was broken out.

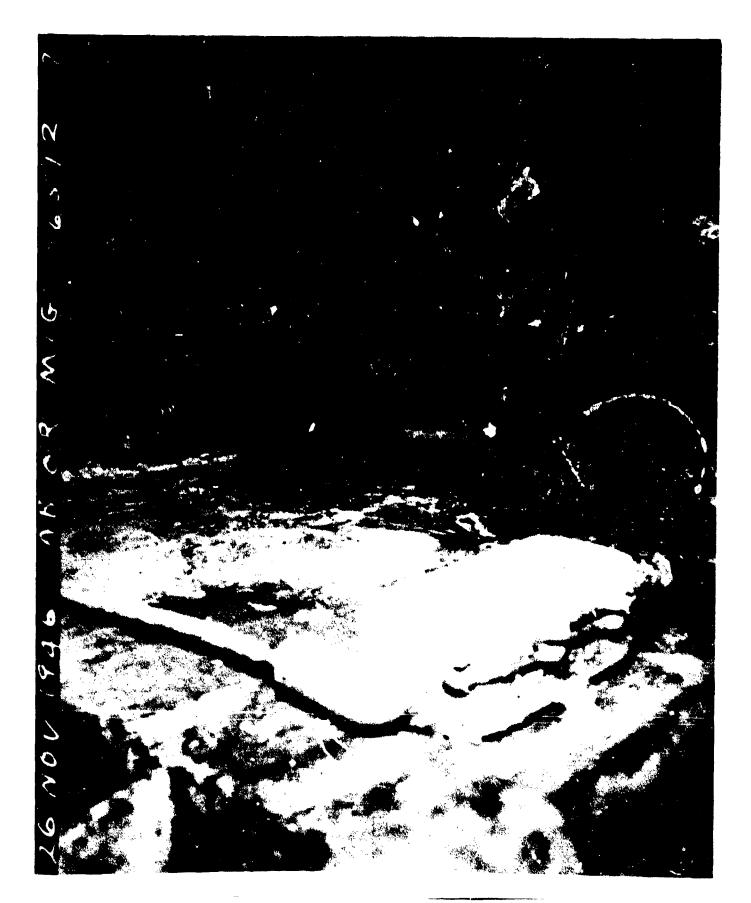
AB-CR-MIG-6512-7. No. 2 main motor sea suction valve - 100 showing leak under flange.

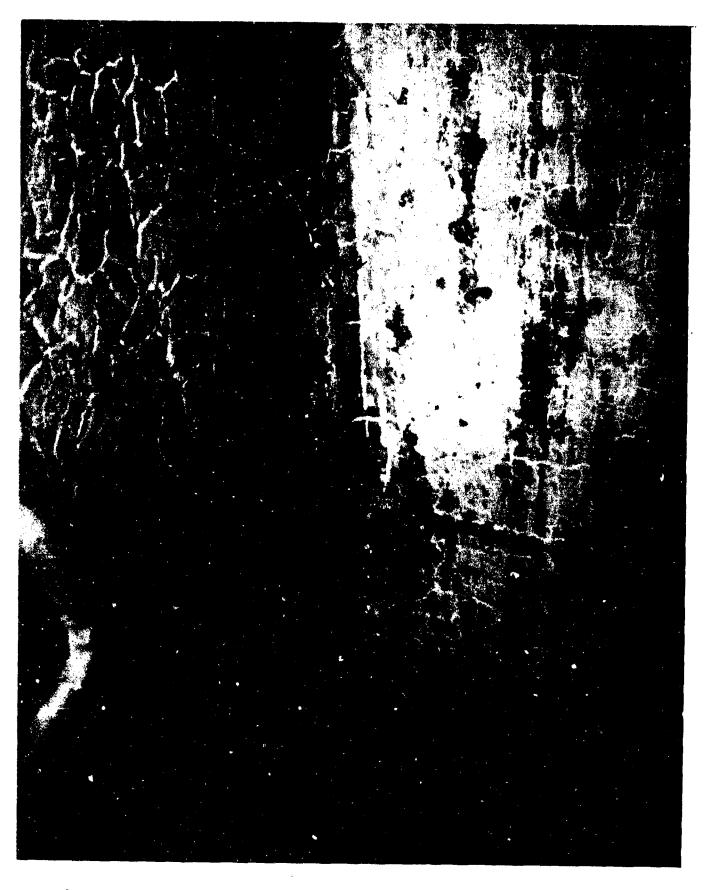
AB-CR-MIG-6513-3. Buckle in forward bulkhead of port safety tank. Looking outboard.

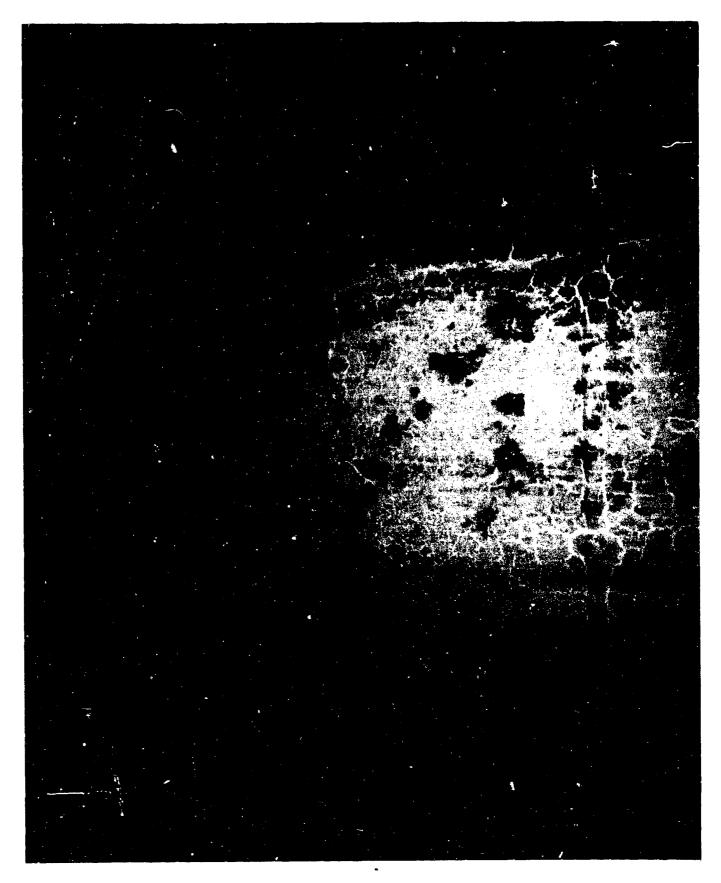
AB-CR-MIG-6513-4. Buckle in floor at frame 90 and after bulkhead of starboard safety tank. Looking outboard.

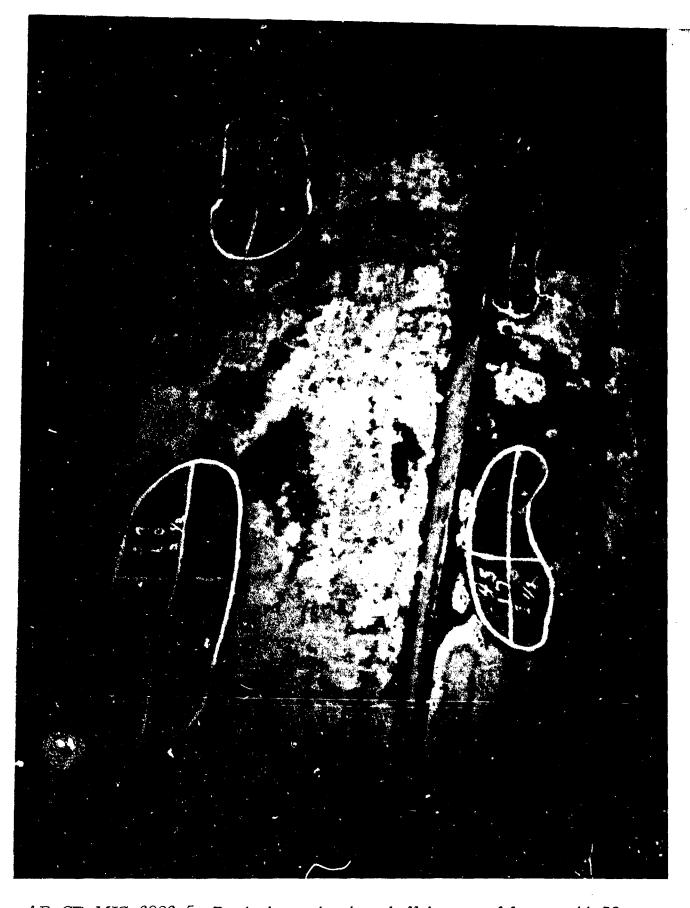
AB-CR-MIG-6226-5. Dents in port outer shell in way of frames 44-58.

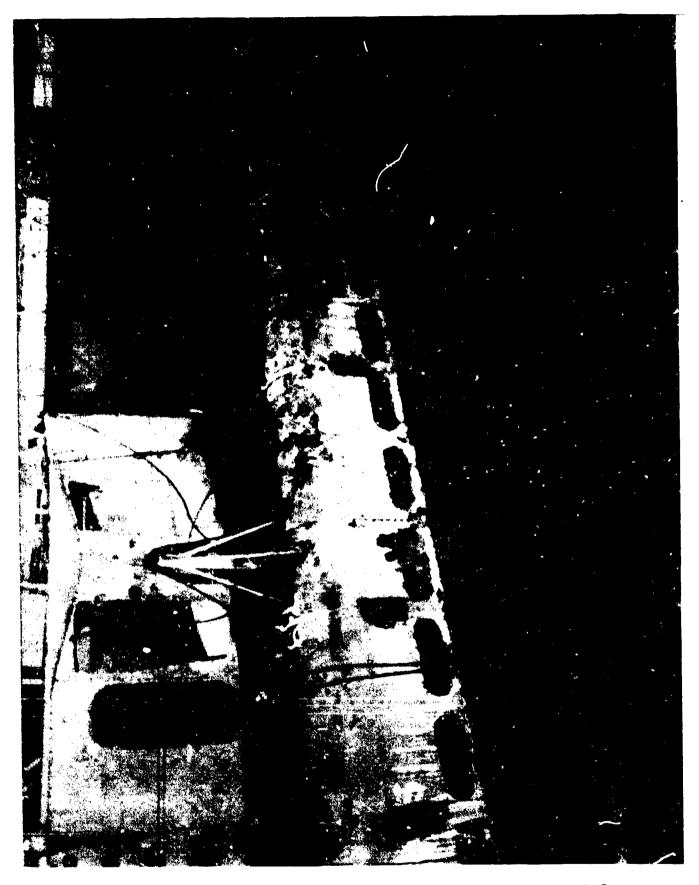
AB-CR-MIG-6529-1. Dent in tank top in way of main ballast tank $2\ \mathrm{D}$.

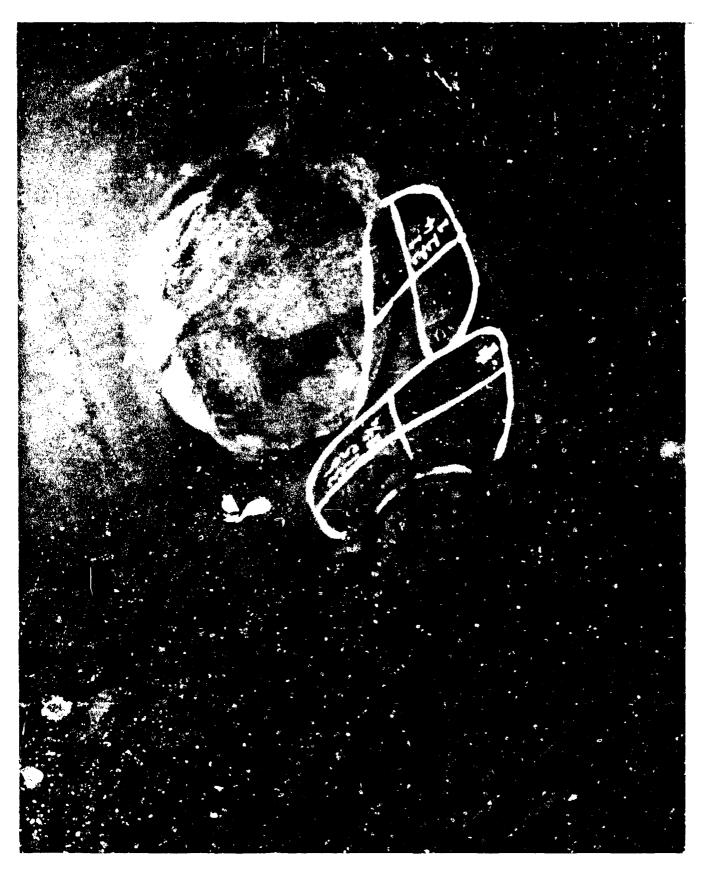
A B-CR-MIG-6525-4. Port shell in way of flood valves for main ballast tank No. 3.

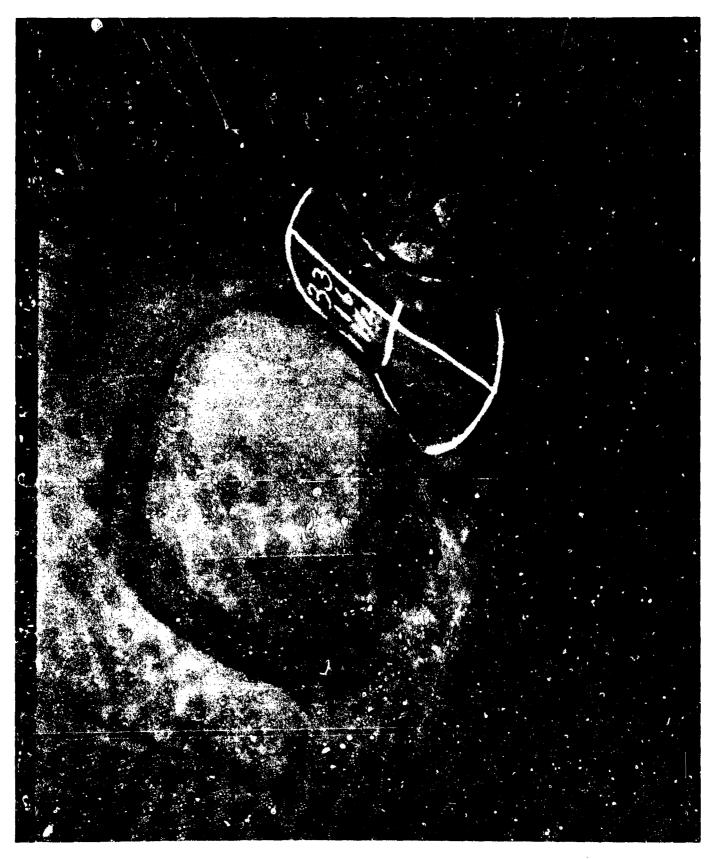
AB-CR-MIG-6525-3. Starboard shell in way of flood valves for main ballast tank No. 3.

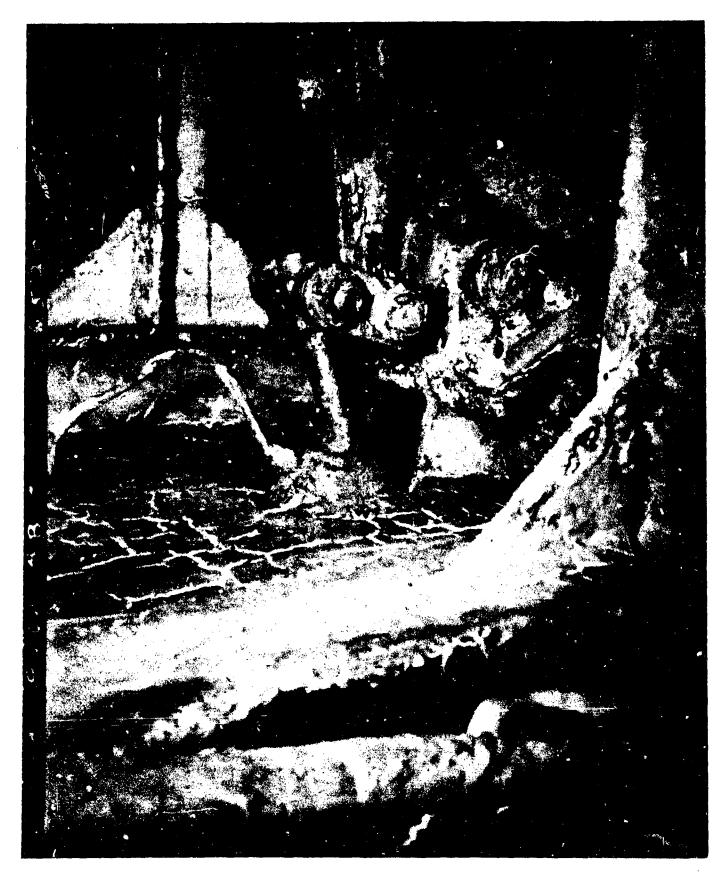
AB -CR-MIG-6520-4. Upper bell crank assembly for flood valve in main bailast tank 2 B. Note bent shaft.

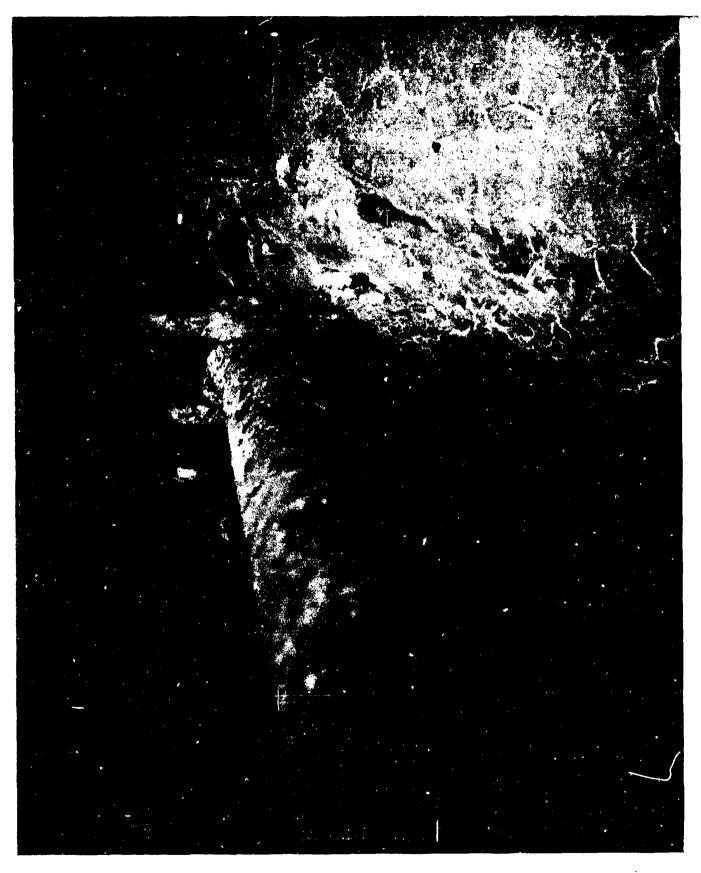
AB-CR-MIG-6520-7. Lower bell crank for flood valve in main ballast tank 2 B. Note interference with air flask.
